# How Rexroth Gave Keymark's 50-Year-Old Aluminum Extrusion Press a Modern Overhaul

**Keymark Corporation, established in 1964, is a leading aluminum extrusion manufacturer, creating a variety of custom and standard extrusions, as well as other value-added aluminum products, for an array of U.S. industries.**

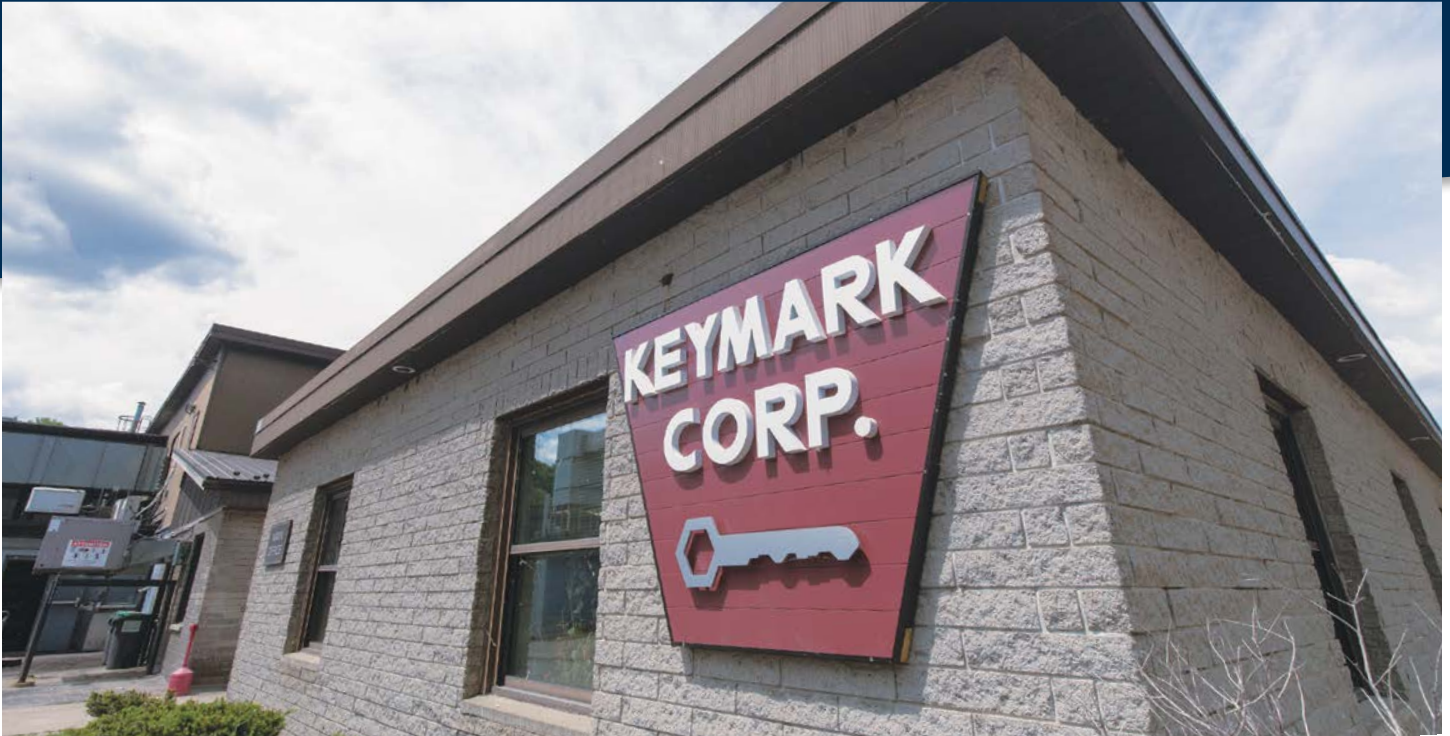
**Keymark's factory in Fonda, New York, contains four extrusion lines, where aluminum billets are heated to around 900 degrees Fahrenheit, then pressed through dies into a variety of custom shapes, such as angles or flat bars. The presses are kept running 24 hours a day, 365 days a year.**

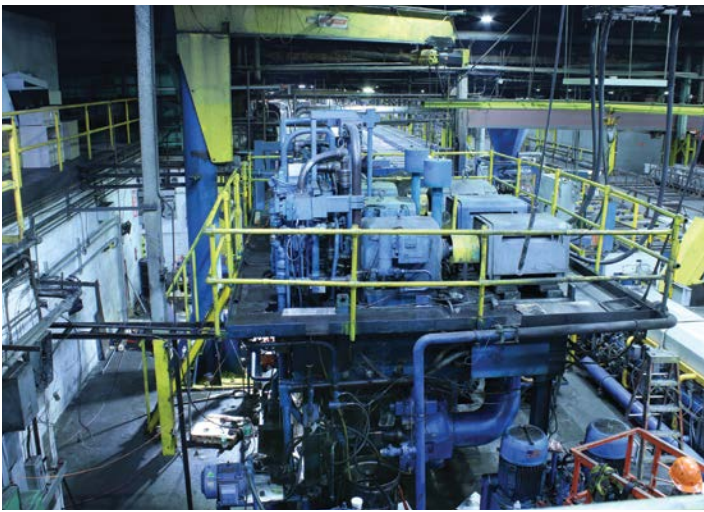
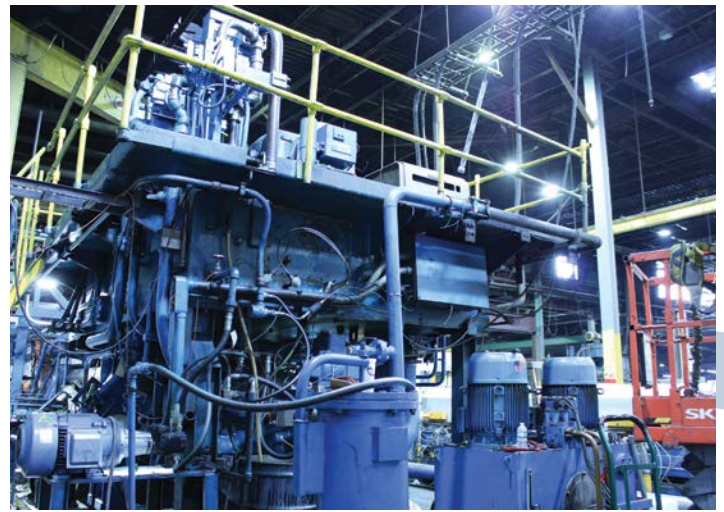
*Images of the system before modernization, showing obsolete legacy components and complex piping.*

Keymark's 8-inch press was installed in 1971 and had been in service for more than 50 years when the company decided to begin exploring options for upgrading or replacing the unit. By 2021, the press was experiencing a high breakdown rate, resulting in frequent lost production time. Among other ongoing issues, the side walls of its container shifting cylinders were scored and leaking, making it difficult to hold the necessary level of pressure.

Other than a few minor upgrades, the press still had many of its original parts from 1971. Because new replacement parts for the press were no longer available, Keymark was forced to buy used parts or send its broken ones out to be refurbished, a process that often took days or weeks. The press's operational integrity was becoming a concern as the likelihood increased that a future breakdown would be very challenging and difficult to fix, leading to prolonged downtime.

As one of the top names in hydraulics worldwide and a manufacturer of many of the components used in aluminum extrusion presses, Rexroth was a natural choice to perform this major upgrade project. Rexroth initially presented Keymark a range of options, from minor upgrades (changing pumps, upgrading manifolds) to a complete hydraulic and control modernization. In the course of discussion, Keymark ultimately opted to leave the bones of its original press from 1971 – including its front and rear platens, its main ram housing and its tie rods – but have Rexroth replace the entire hydraulic power unit, electrical controls, prefill valve, transducers and piping.

The new power unit, built at Rexroth's factory in Bethlehem, Pennsylvania, included a roughly 3,000-gallon steel tank, three 200-hp electric motors with three A4VSO axial piston pumps and custom manifolds.

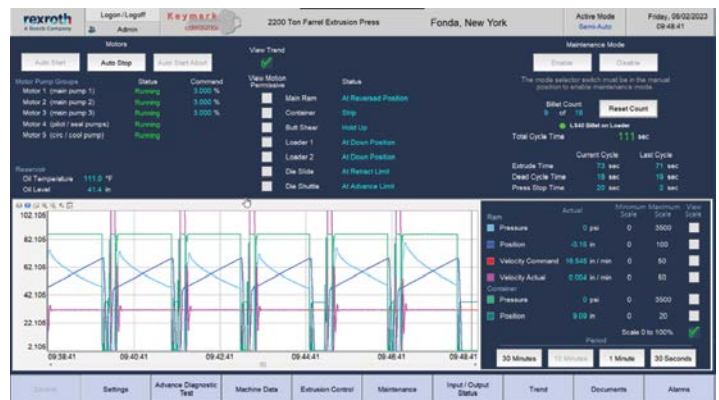
**The main control screen offers real-time performance data display, status of critical parameters, and intuitive navigation to all other control system function screens.**

The electronic control system uses Rexroth's extensive knowledge of how to manage pressure within a system, resulting in the fastest, smoothest possible operation. Keymark opted for Rexroth's Advanced Diagnostics troubleshooting package, which utilizes a collection of embedded sensors to monitor the system at all times. Using a touchscreen, users can go through individual areas step by step to discover where failures have occurred. This significantly shortens the time needed to identify a problem, from several hours to as quickly as a few minutes.

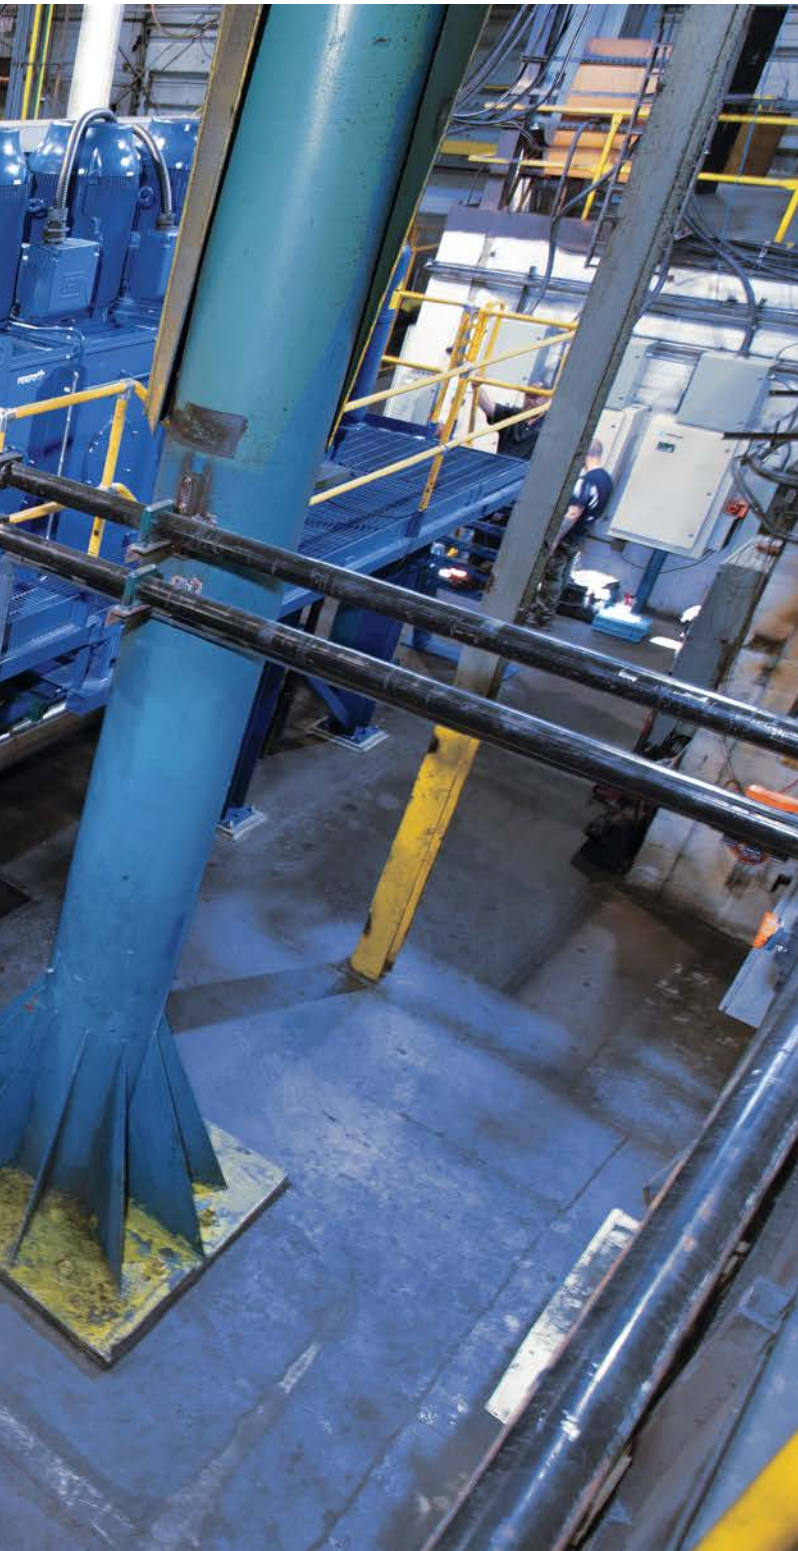
“We’ve really found it useful on the mechanical side for troubleshooting issues and for testing. We can force valves different directions if we want. We can see pressures everywhere – where we’re spiking, where we’re not spiking,” said Shawn Gavin, manager of Keymark’s plant. “It’s just made a world of difference as far as the troubleshooting goes. I definitely would highly recommend it to anyone getting an upgrade.”

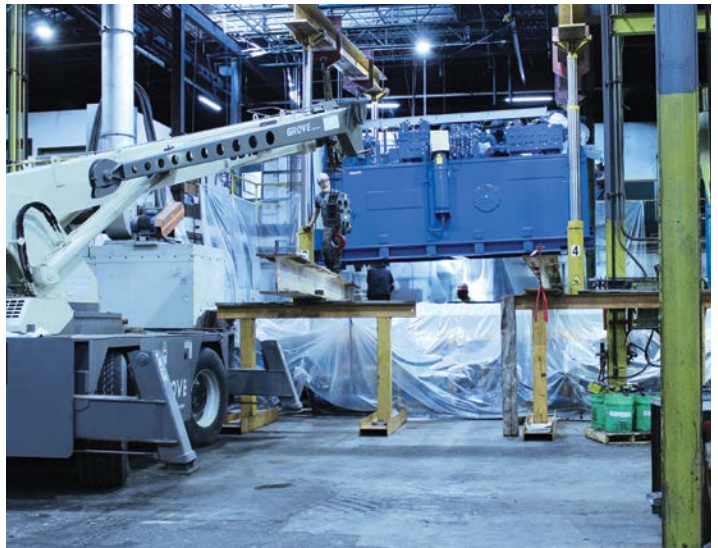
*The power unit had to be carefully rigged into position above existing equipment.*

The unit, weighing 50,000 pounds, needed to be moved with cranes into place over the press, sitting in a specific location so all the pipes would line up perfectly. Before the installation, Rexroth met with contractors on the project and shared all the necessary specifications to ensure the process would go smoothly. A team of Rexroth technicians, control engineers, and hydraulic engineers then spent three weeks on site at Keymark overseeing the final install and getting the new unit into production.

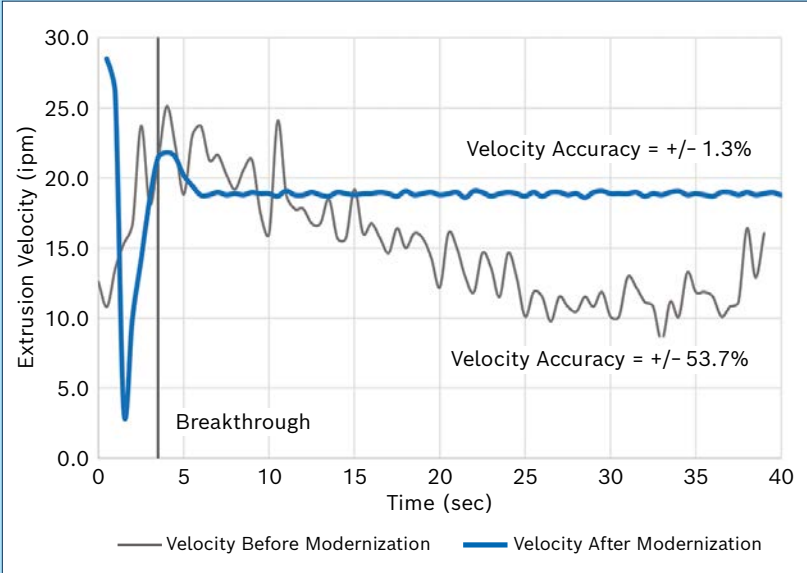
### Velocity Control Before / After Modernization

**The new system greatly improved extrusion velocity control, improving quality and reducing scrap rates.**

Another benefit of the new Rexroth system is greatly improved extrusion velocity control. The speed at which the product is extruded is critical to the quality of the parts being produced, because a constant velocity during extrusion has a direct influence on surface finish, tolerances, and material properties. However, many older systems are not able to accurately control the speed because of the varying dynamics inherent in the process. The top graph to the left shows the dramatic improvement in extrusion velocity control provided by the new Rexroth system. The grey line (before the modernization) shows the velocity varying over 50% while the new system (blue line) is constant, varying only 1.3% throughout the cycle. This improved level of control will help reduce scrap rates and may allow a press to make higher-value automotive or aerospace parts that it was not capable of in the past.

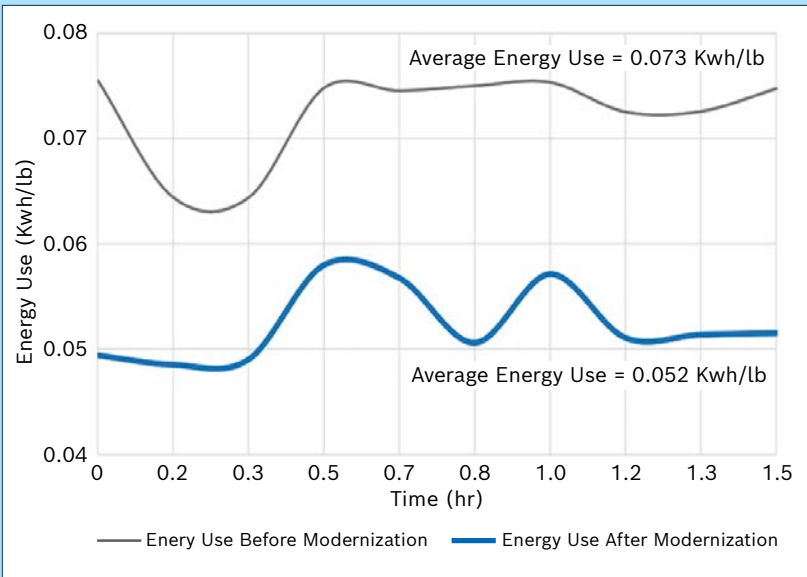
### Energy Use Before / After Modernization

**A 28% reduction in energy use (on a pounds per hour basis) was realized, saving about \$25,000/year.**

Gavin says the improvement in energy efficiency is dramatic. Whereas the old system would run all motors simultaneously during an extrusion cycle, the new unit only runs its three motors during the dead cycle time, then drops down to one during the extrusion cycle as the other two idle. After each billet, the control “cascades”

to another motor for the next billet, which helps extend the pump and motor lifespans by equalizing the work. In addition, the electric motors, pumps and valves are all much more efficient than the worn-out legacy components they replaced. The end result is a 28% average energy use reduction as shown in the bottom graph to the left.

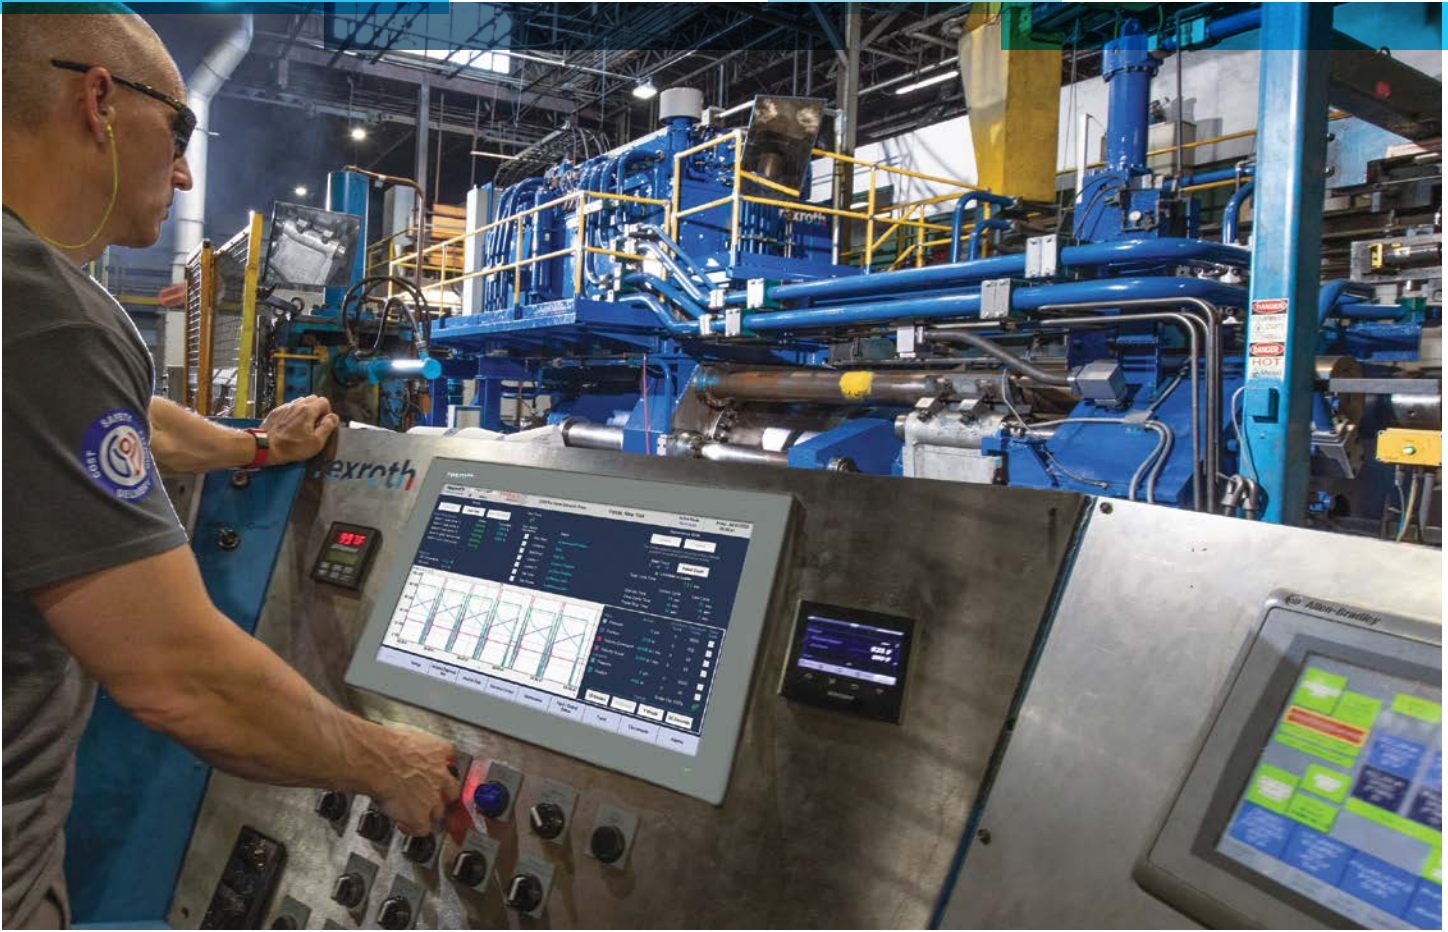
*The modernization provided a 20% productivity increase while improving quality and reliability and reducing energy use.*

Since going online in June, the upgraded press has shown a dramatic improvement in performance and reduction in downtime. The press’s dead cycle time – the time between when it finishes its last extrusion to when it starts the next extrusion cycle – used to be between 28 and 29 seconds “on a good day,” Gavin says. Now, it’s an average of 20 to 21 seconds. The 8-inch press is now even outproducing an older 9-inch press at the same factory.
