Superior Extrusion keeps press running *faster than ever* with drop-in hydraulic solution from Bosch Rexroth.

CASE STUDY

Hydraulics Upgrade Provides Unexpected Benefits for Aluminum Extrusion Press

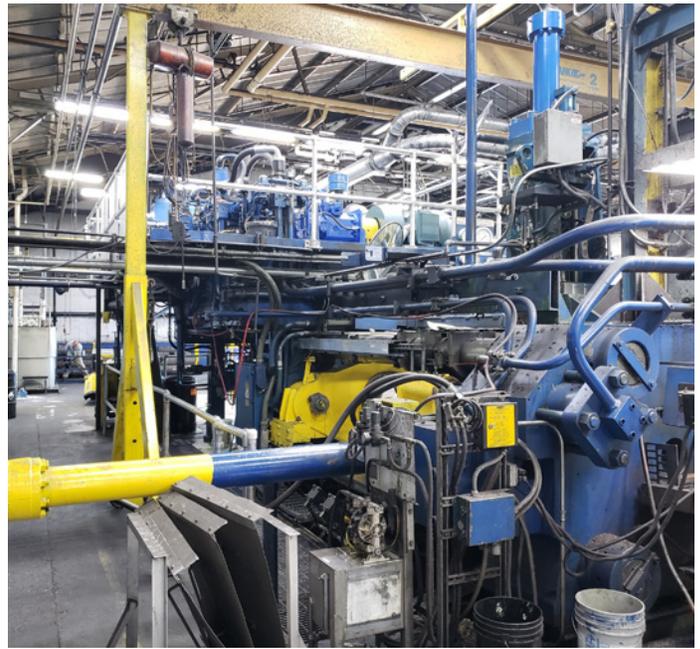
The Bosch Rexroth team worked closely with Superior Extrusion to design a drop-in solution comprised of Rexroth A4VSO 500 axial piston pump, custom manifold, Rexroth LC and LFA logic valves and custom-programmed HACD digital electronic control.

Superior Extrusion's project was the first opportunity to apply the tested drop-in concept. At the solution's heart was a Rexroth A4VSO 500 axial piston pump.

The Bosch Rexroth team also incorporated a custom manifold circuit designed to replicate the two-way function with two pressure ports in the exact same location as the legacy pump. Two-way cartridge valves (type LC and LFA) then directed the oil to the correct port. The solution conserved as much of the existing configuration as possible so that it bolted directly to the existing piping. The new Bosch Rexroth pump manifold deckplate preserves all of the existing press piping.

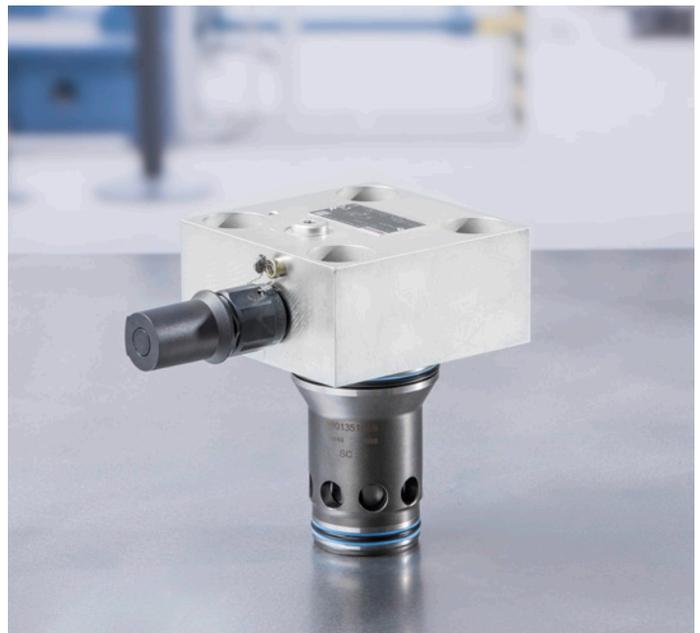
Oil is directed to the correct port with type LC and LFA two-way cartridge valves.

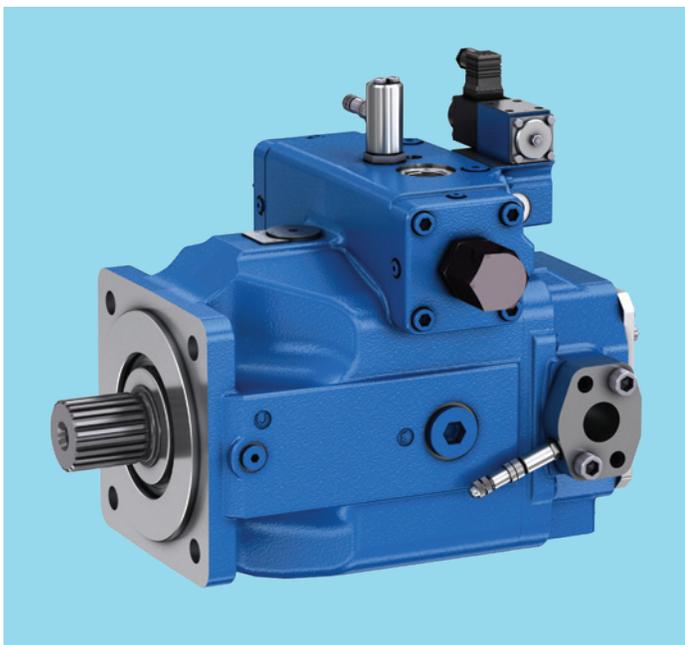
The Rexroth A4VSO 500 axial piston pump was the heart of the drop-in solution.

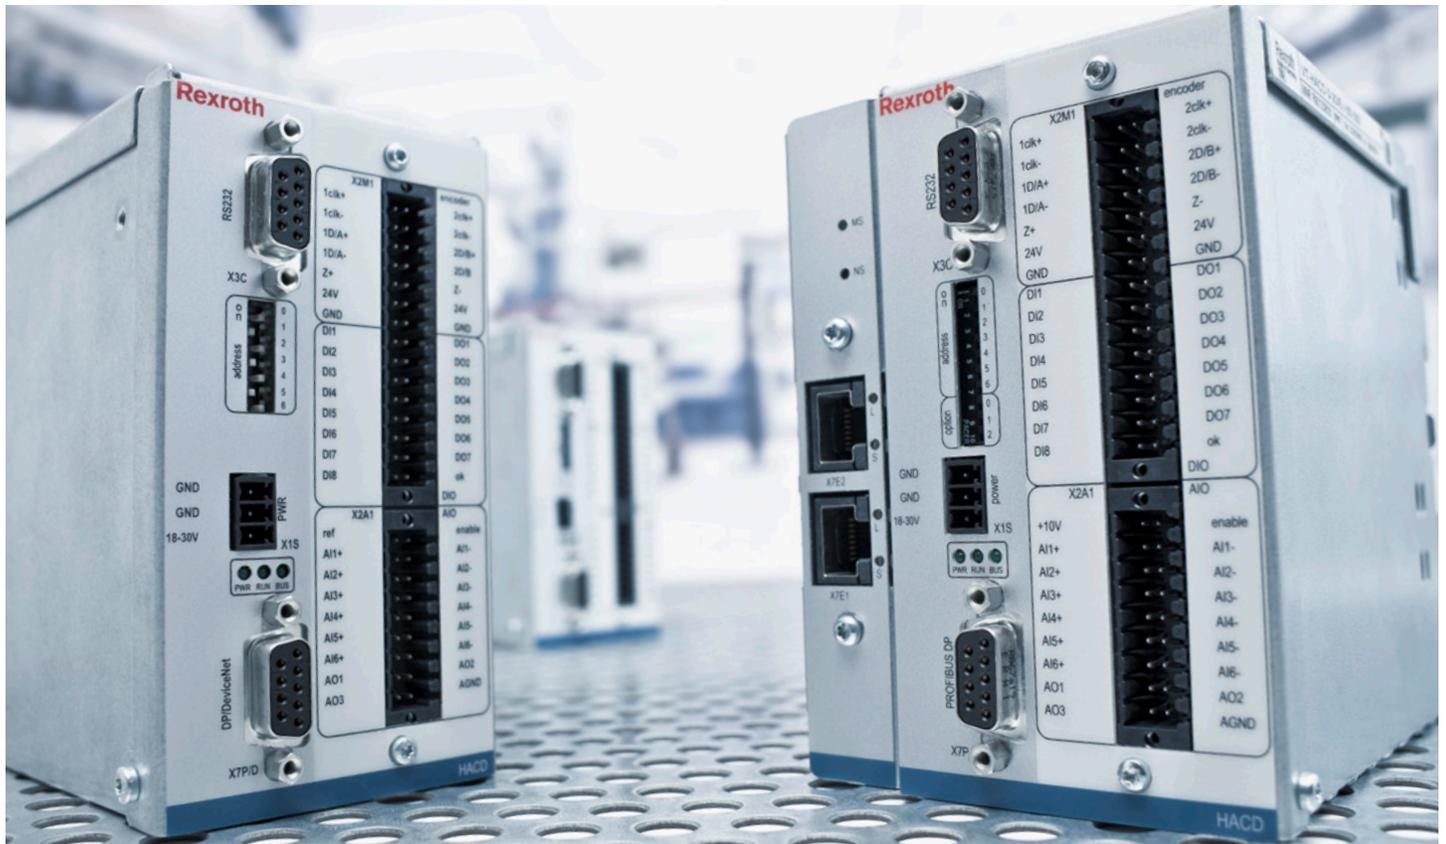
An HADC digital electronic control was configured to take the existing analog signals that previously controlled the legacy pumps and use those outputs to control both the A4VSO piston pump and the LC and LFA valves.

To control flow through the pressure ports, an HACD digital electronic control was configured to take the existing analog signals that previously controlled the legacy pumps and use those outputs to control both the A4VSO pump and the LC and LFA valves. This significantly simplified the controls challenge of swapping out the legacy pump and valves with the current generation of hydraulics.

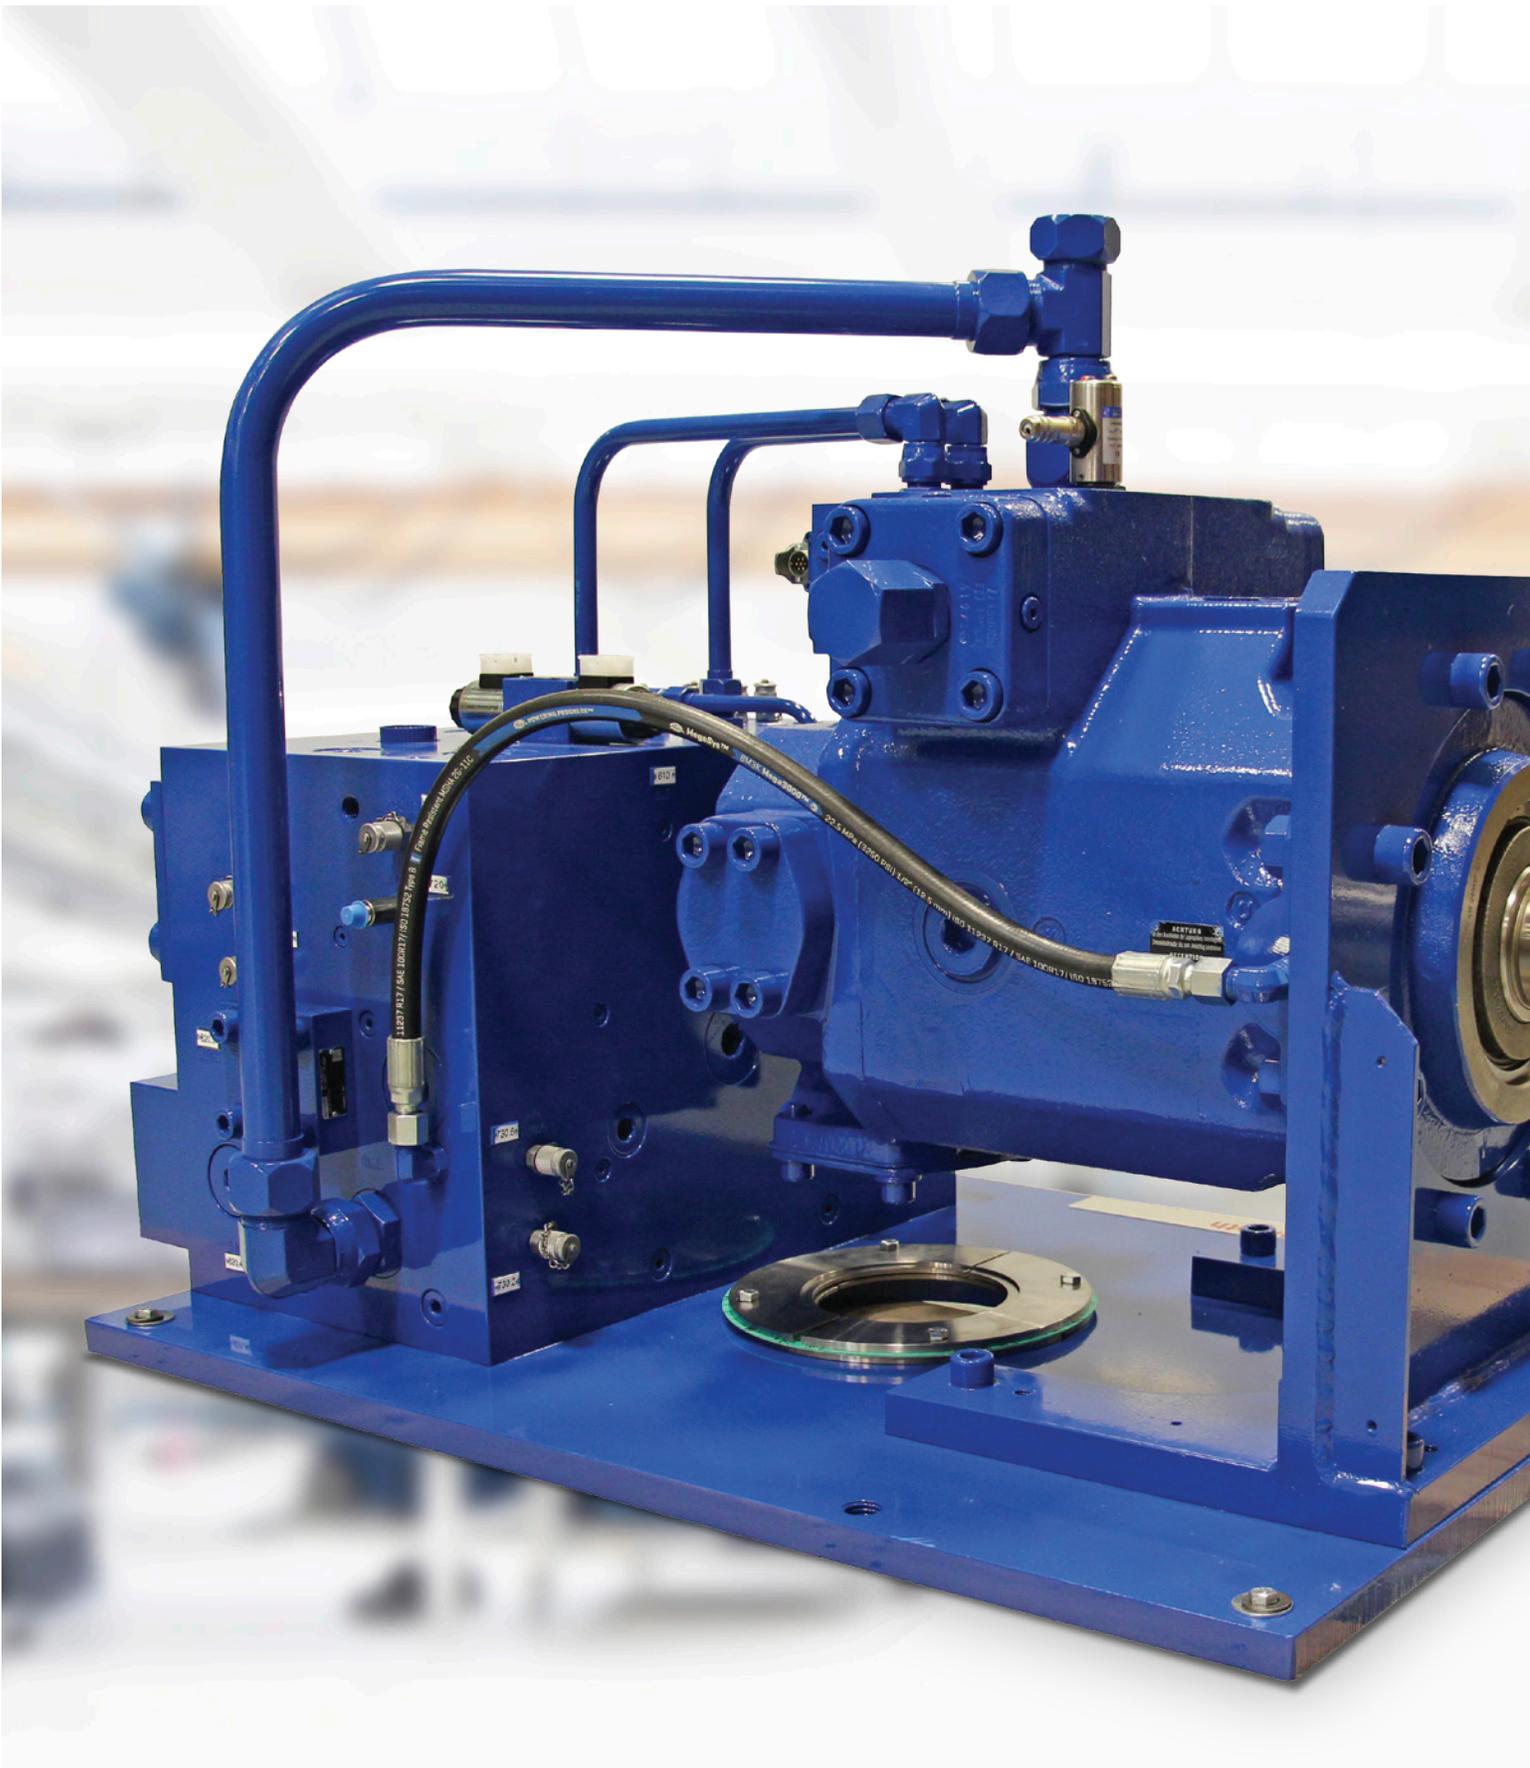
Bosch Rexroth engineered a solution to directly match the way the older hydraulic components operated.

The nature of the original pumps required an engineered solution that would match the way older components operated. Leading the project was Michael Kramer, press application engineer at Bosch Rexroth. According to Kramer, the original pump sat on top of the tank, drawing oil up from the reservoir and supplying it to the system through two supply ports.
