S U C C E S S   S T O R Y   |   L K A B

# An impressive iron ore mine invests in efficiency deep down

# LKAB Malmberget invests in efficiency deep down

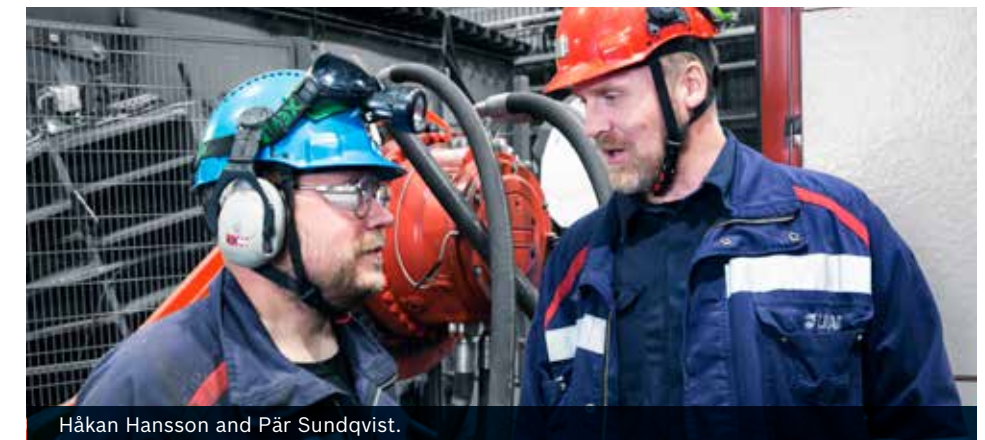
Håkan Hansson and Pär Sundqvist.
