Hydraulic Actuators for Gas and Steam Valves

Failures and high costs can be prevented with planned maintenance

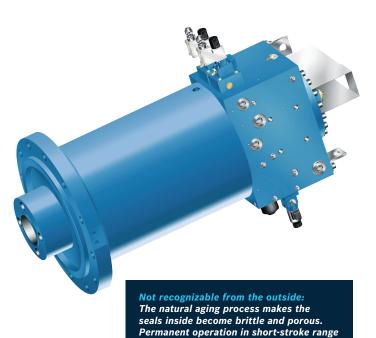
additionally limits the sealing effect.

In addition, uncontrolled steam discharge can damage the actuator due to overheating of the hydraulic fluid, because the fluid temperature must not exceed 70°C in circulation. If the system cannot compensate for the influx of heat, the hydraulic oil will be "burnt". This means that it becomes viscous and sticky. The seal wear increases, while valves and other components lose their freedom of movement and function.

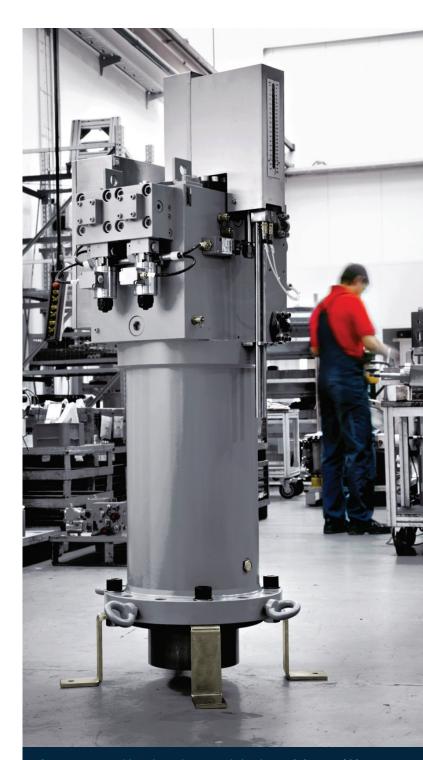
Safety-relevant component: The spring assembly inside the cylinder brings the valve into the safety position purely mechanically in the event of a malfunction. If it breaks due to corrosion, the actuator loses its safety function.

At the interface to the armature – the coupling – the ambient temperature must not exceed 200°C. As a result of the effects of excessive heat, the existing anticorrosive coating – consisting of a layer of wax on the Belleville washer system – can be damaged. If a rusty spring cup breaks, the actuator loses its safety function. In this case, the component requires an immediate overhaul in a manufacturer's certified service center.

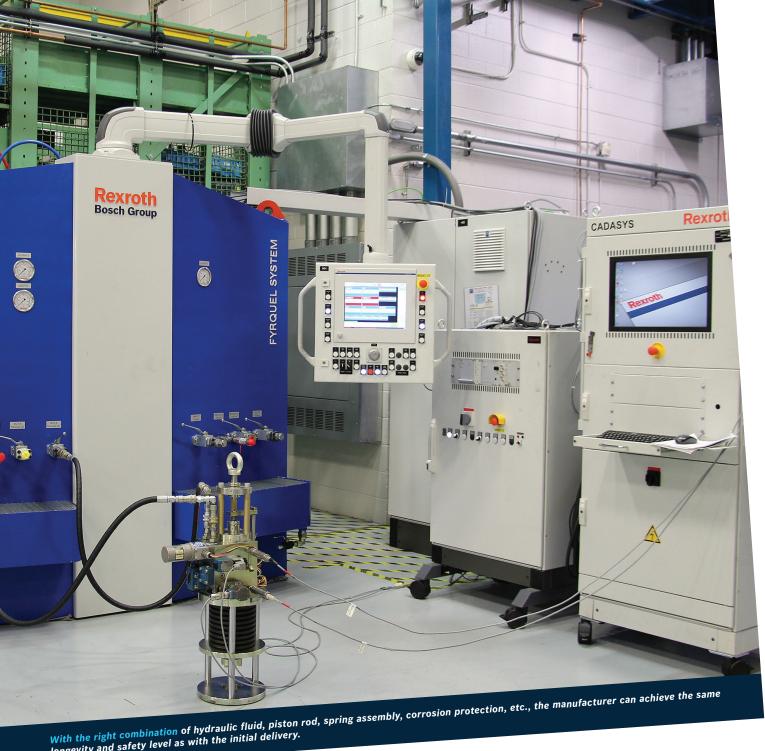
longevity and safety level as with the initial delivery.
